Packery Channel, Baseline Physical Process Monitoring Overview and Status

October 17, 2006

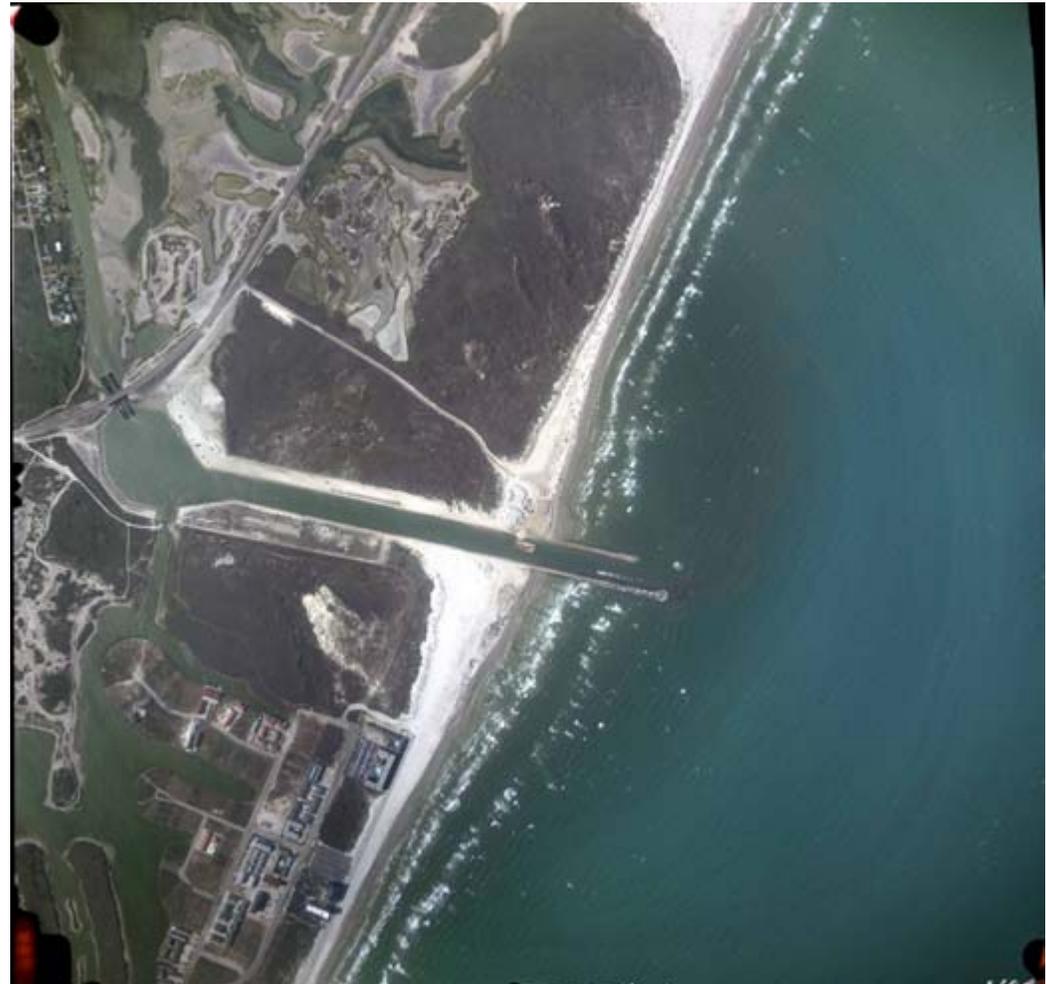
May 06, before north jetty completion

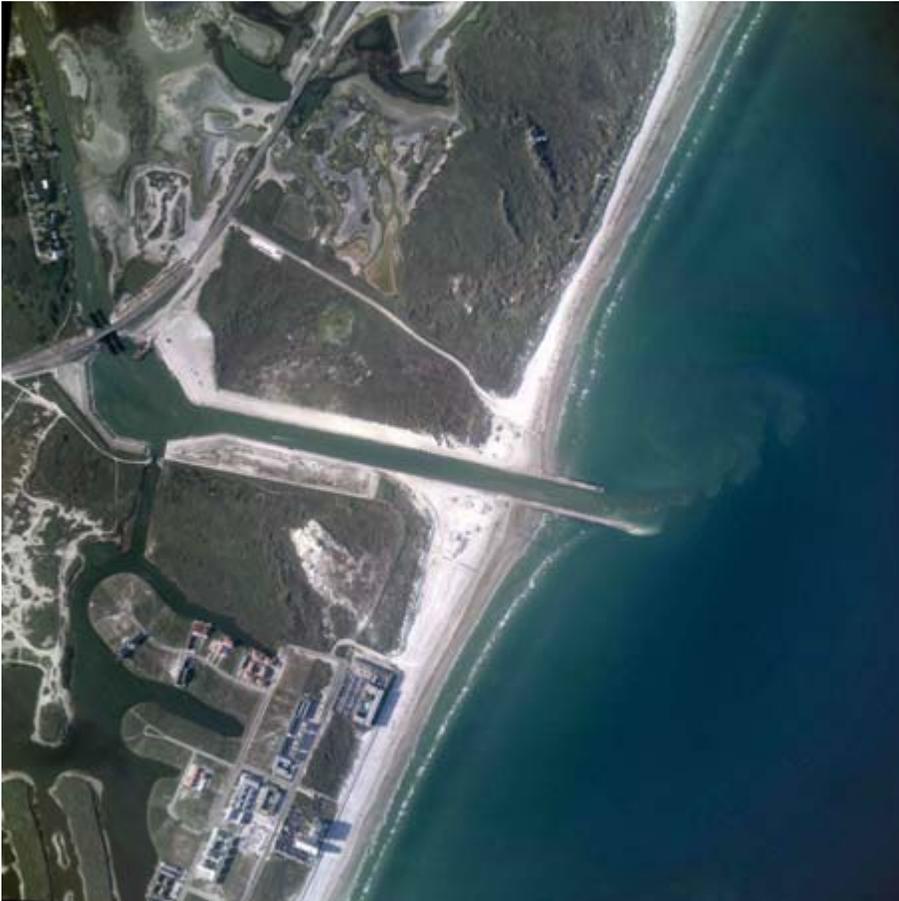
4 Aug 05

1. Oct 03. Construction began.
2. Dec 03- Ap 04. Dredged and placed 110,000 cu yd of sand along southern shoreline to Whitecap (end of seawall).
3. Jul 05. Channel opened by H. Emily.
4. Aug-Sep 05. Storm surge associated with Rita and Katrina impacted area.
5. Jul-Dec 05. Narrow channel remains open.
6. Jan-Feb 06. Dredging of channel, partial placement at south end of seawall.
7. Mar 06. S. Jetty complete to 1,400 ft.
8. Oct 06. N. Jetty complete to 1,400 ft.

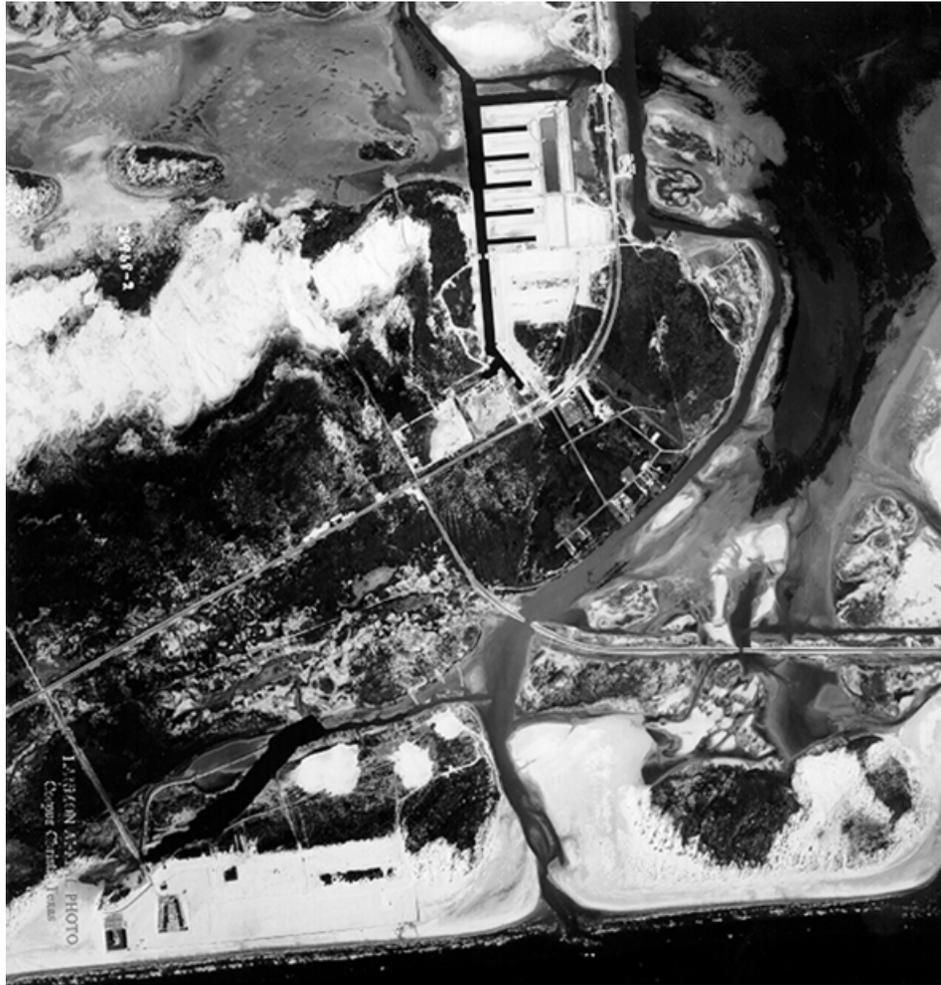
Packery Channel expected to be stable, relatively easy to maintain, and cause moderate shoreline change because:

1. A historic hurricane overwash pass and historic entrance to Corpus Christi Bay.
2. Designed to have low jetty width to channel depth ratio (hydraulically efficient).
3. Located in Gulf of Mexico near zero net littoral sand drift.
4. Located in southeast corner of bay; benefits from current produced by wind fronts from north.

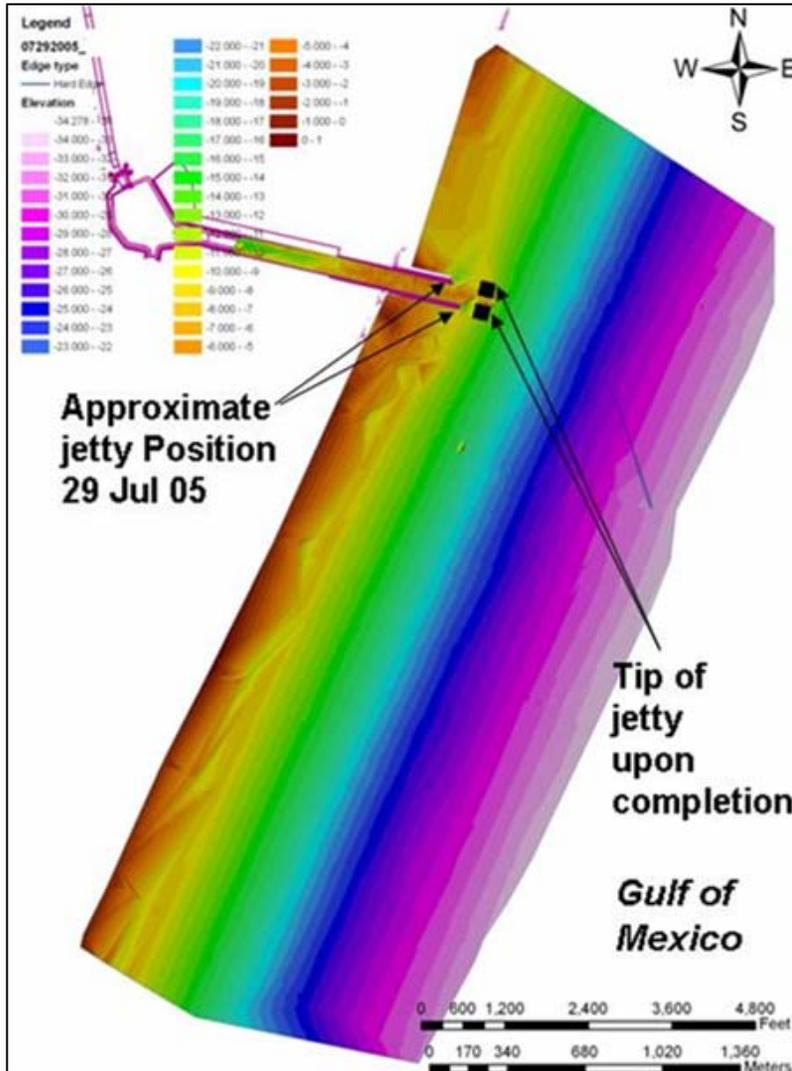
Ebb Shoal Survey 29 Jul 05

1. One week after Hurricane Emily forced Packery Channel open.
2. South jetty $\approx 75\%$ complete and north jetty $\approx 50\%$ complete at that time.
3. Inner Channel depths 12-13 ft NAVD88 (MSL=+0.48 ft).
4. Storm surge opened the channel mouth, producing channel mouth depths of 4-8 ft NAVD88.
5. Depths at projected jetty length are 12-13 ft NAVD88.

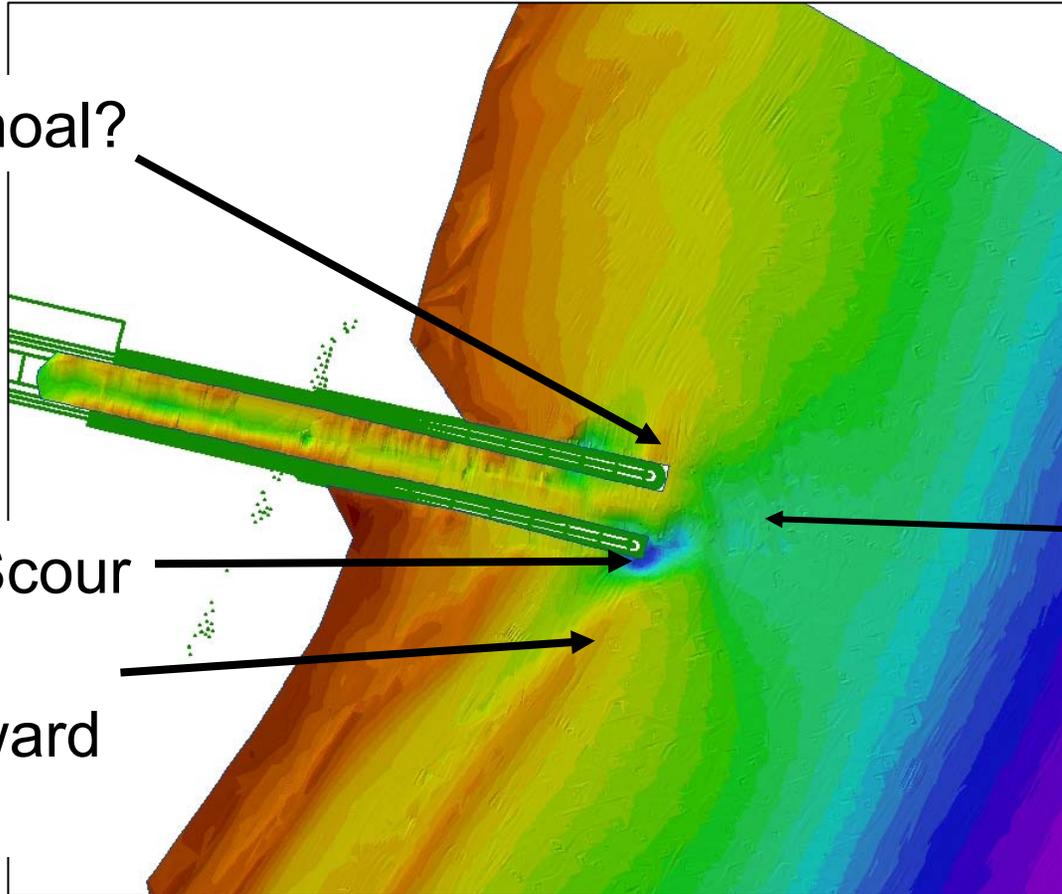
Jetty Tip Shoal?

Still no ebb shoal;
Reduced scour

Scour

Outer bar migration toward entrance

Inner Channel depths 12 to 13 ft NAVD88 (MSL=+0.48 ft).

Channel shoaling (< 7 ft NAVD88) adjacent to jetties.

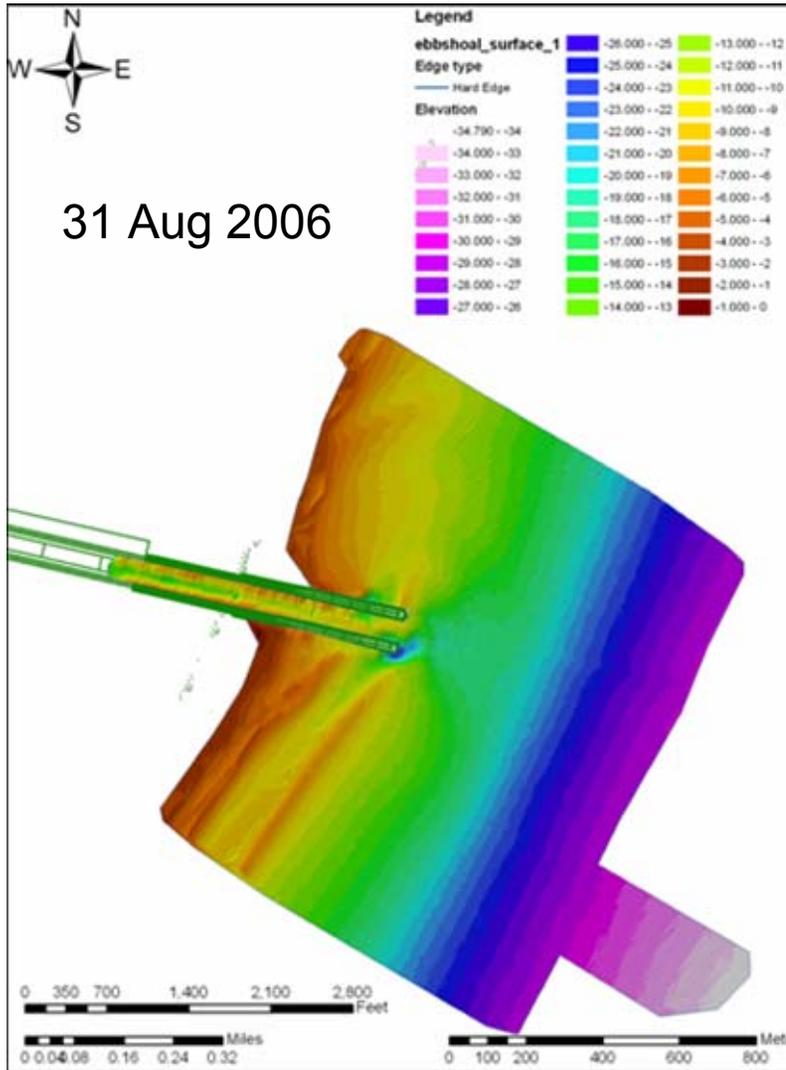
Ebb Shoal

1. At present, no ebb shoal.
2. Channel shoaling between jetties is restricted to central section along north and south jetties.
3. Channel shoaling between jetties increased by incomplete northern jetty and landward gap in armoring.
4. Depth at inlet mouth increased from Jul 05 to Mar 06 and then began to decrease through Aug 06. Depths are approaching those observed in the baseline survey.

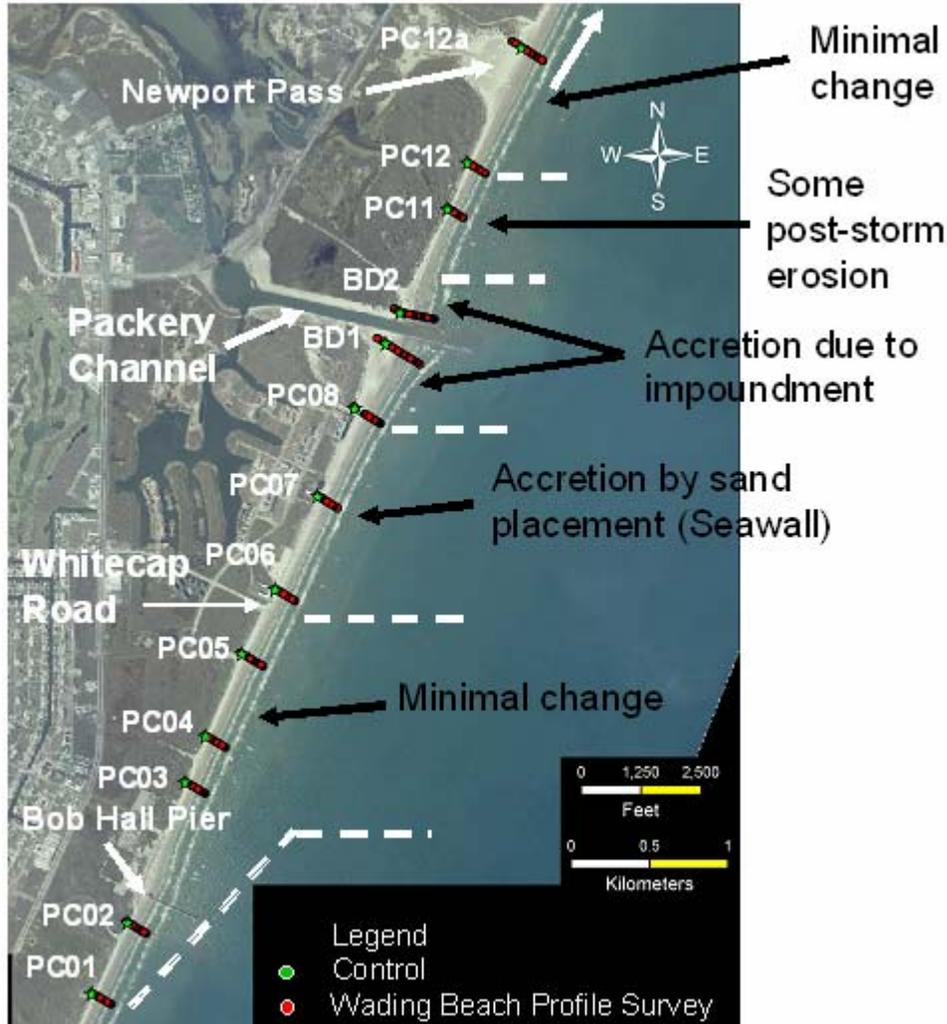
Beach Profile Surveys (Also, available from 1970s & 1996)

1. Slight accretion adjacent to jetties by impoundment.
2. Accretion along seawall by placement.
3. Minimal change at northern and southern extremes.
4. Some sustained post-storm erosion in small region north of inlet (PC11).

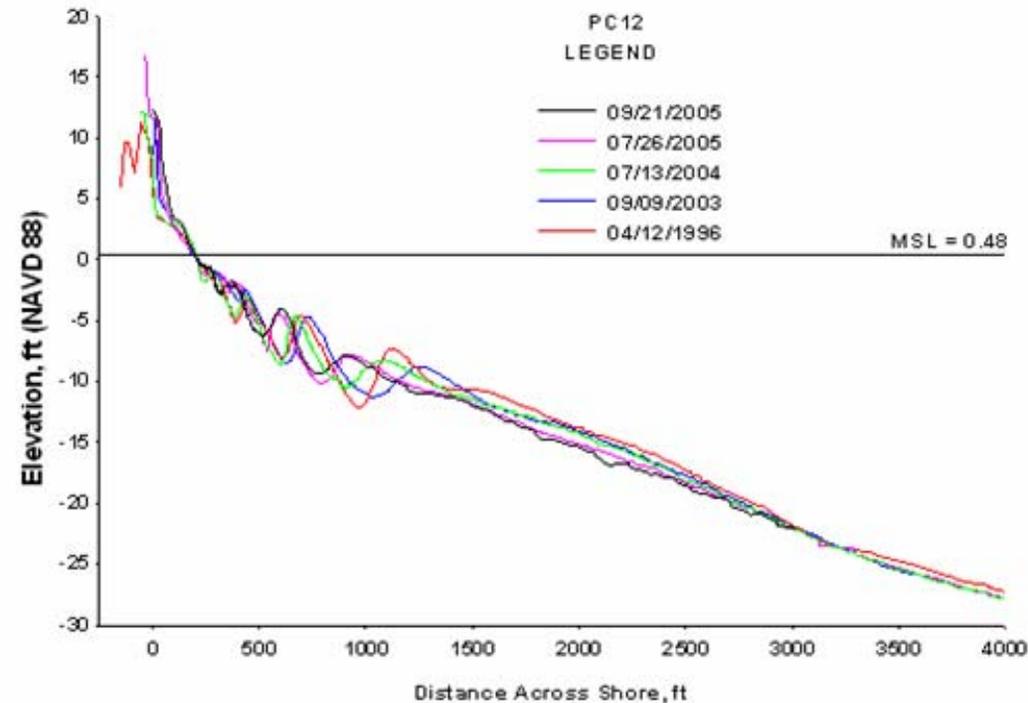
South end of Newport Pass (north of inlet)

1. Minimal change in berm and beach width observed north (Newport Pass to Fish Pass) and south (just south of seawall to Nueces Kleberg County Line) of the inlet.
2. Typically three sand bars.
3. Depth of Closure 16-20 ft NAVD88.

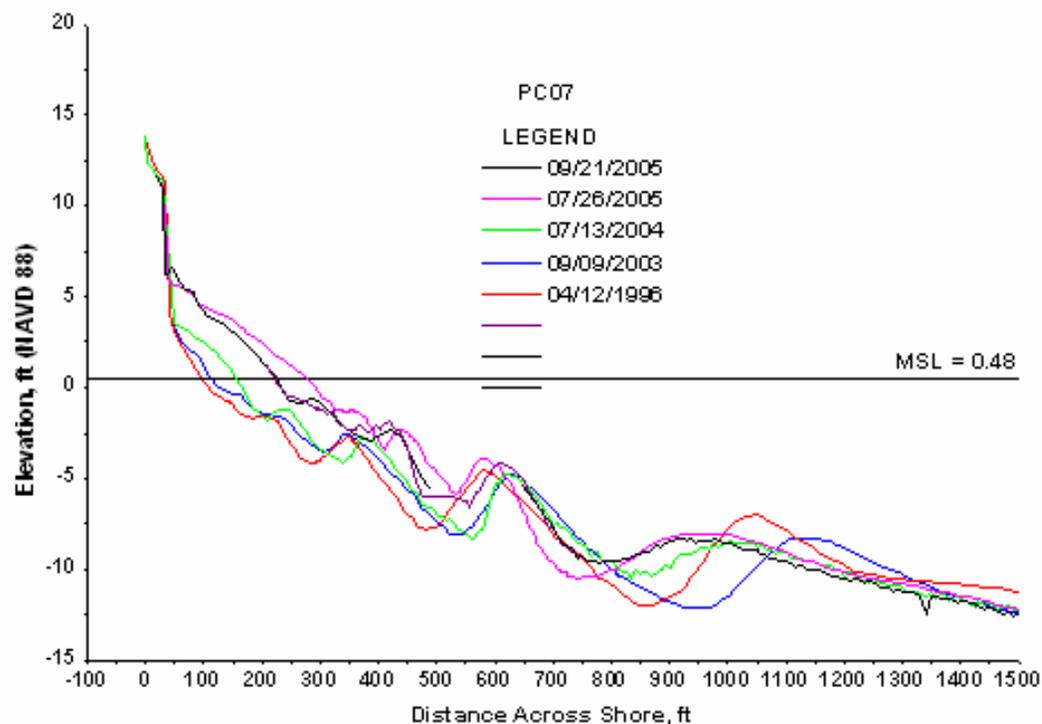
Beach Profile Survey Midway on Seawall (Holiday Inn)

1. Net accretion maintained from BD1 (adjacent to south jetty) south to PC06 (south end of seawall).
2. Some erosion observed during active hurricane season from Jul to Sep 05.

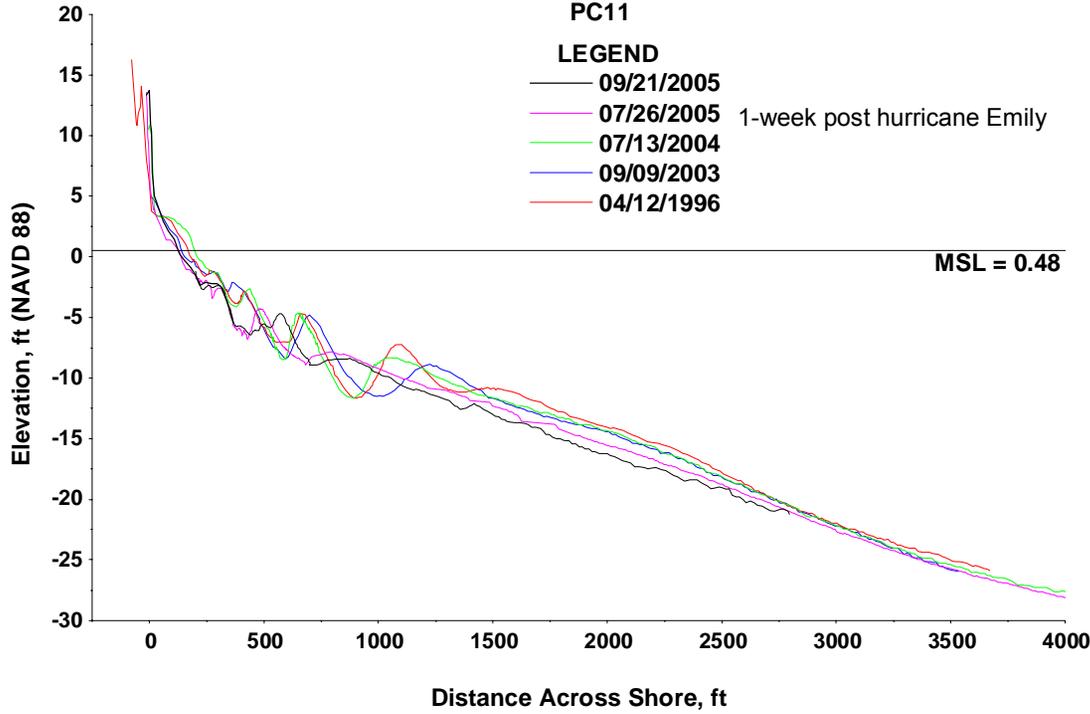
Mid-way between north jetty & Newport Pass

1. Accretion from Aug 03 to Jul 04.
2. Some erosion observed during active hurricane season (Jul to Sep 05).

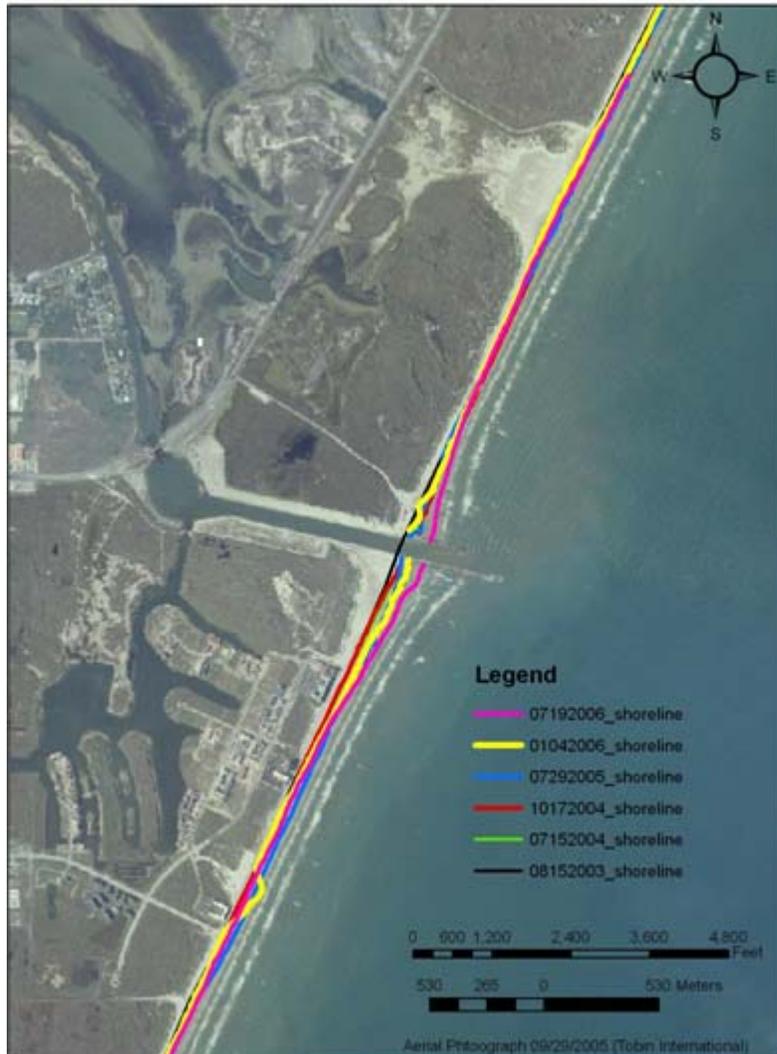
Shoreline Position

1. Shoreline position change dynamic adjacent to inlet and in front of seawall.
2. Shoreline defined as berm crest (1.5-2 ft NAVD88).
1. Shoreline position change decreases within 1/2 mile of inlet to the north and south.
2. Shoreline advancing within dynamic region adjacent to the inlet.

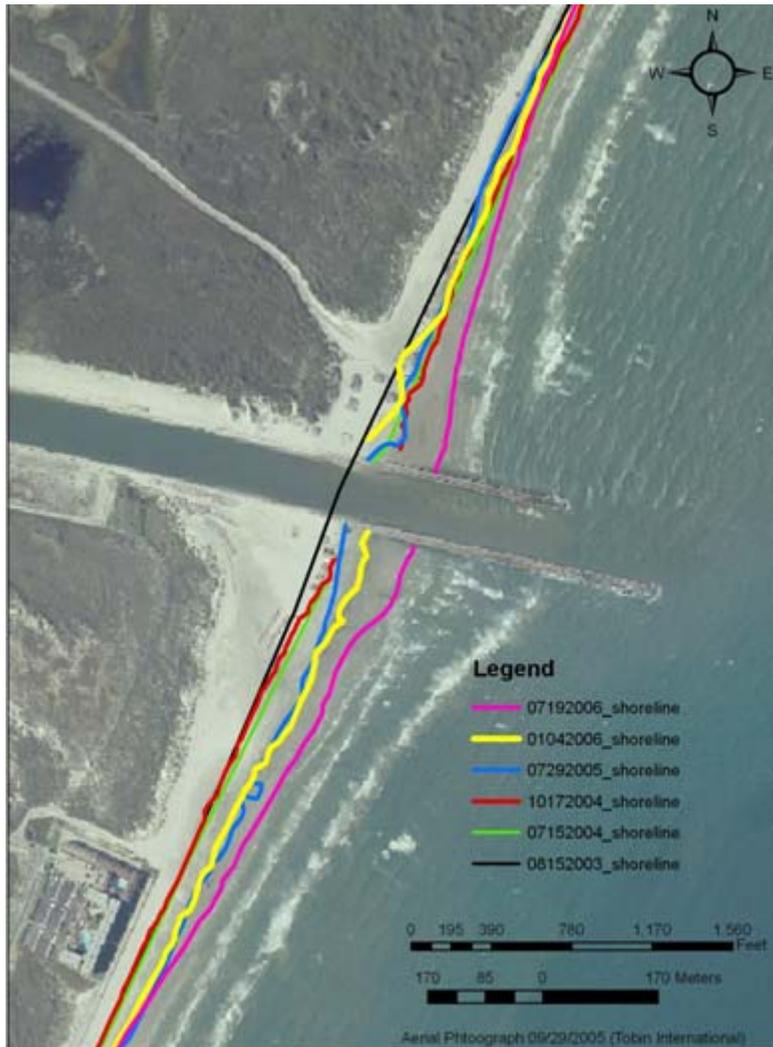
Shoreline Position

1. Shoreline advance adjacent to jetties:
≈ 380 ft on north side
> 400 ft on south side
(15 Aug 03 survey as baseline)
2. South side shows gradual advance over time.
3. North side more erratic prior to Jul 06 due to losses sustained through gap in north jetty during storm surges.

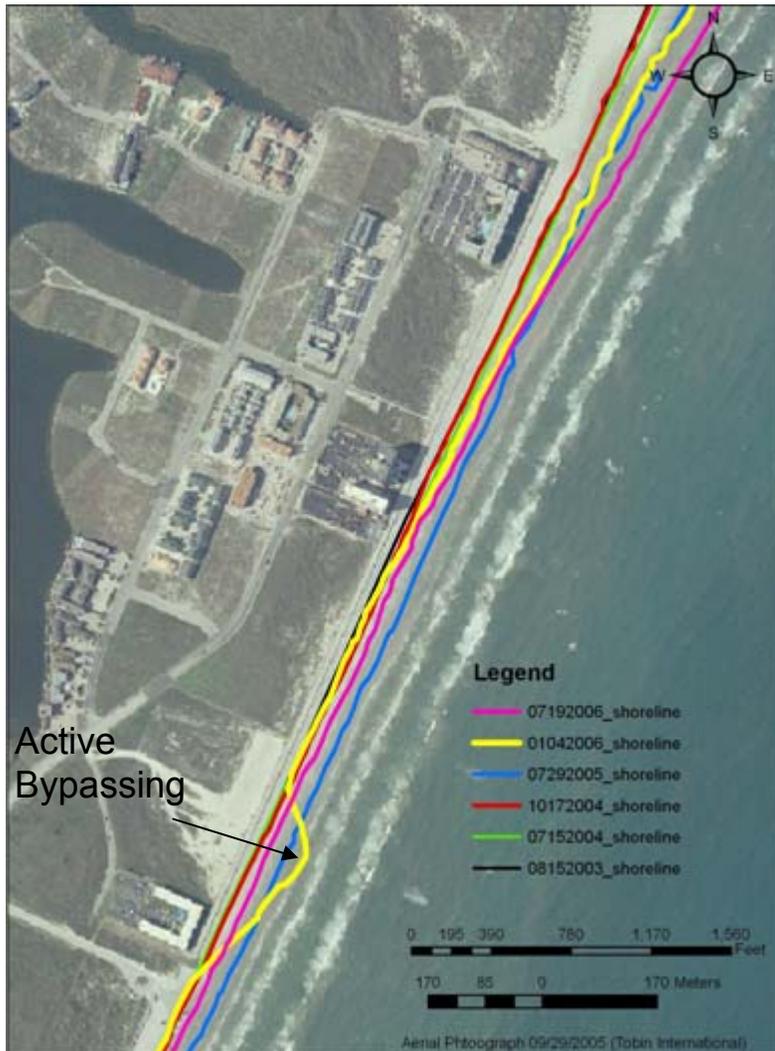
Shoreline Position

1. Shoreline advance on the order of 60 ft (south end) to - 200 ft (north end) in front of the seawall as of 07/19/2006.
2. Post-Hurricane Emily survey (29 Jul 06)
3. Active period of sand placement (4 Jan 06 -- yellow line)

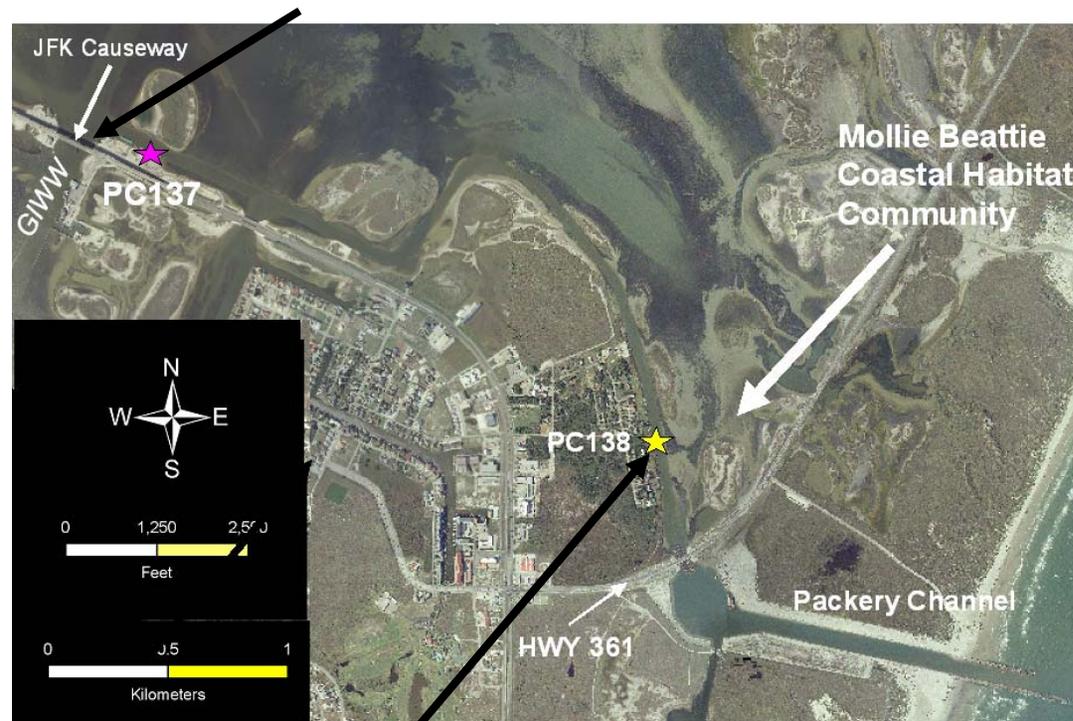
JFK150
Center of GIWW under the JFK Bridge

PC138
North of HWY 361 Bridge

1. Real-time measurement of current speed and direction.
2. Online access to current data.
3. GIWW and in Channel

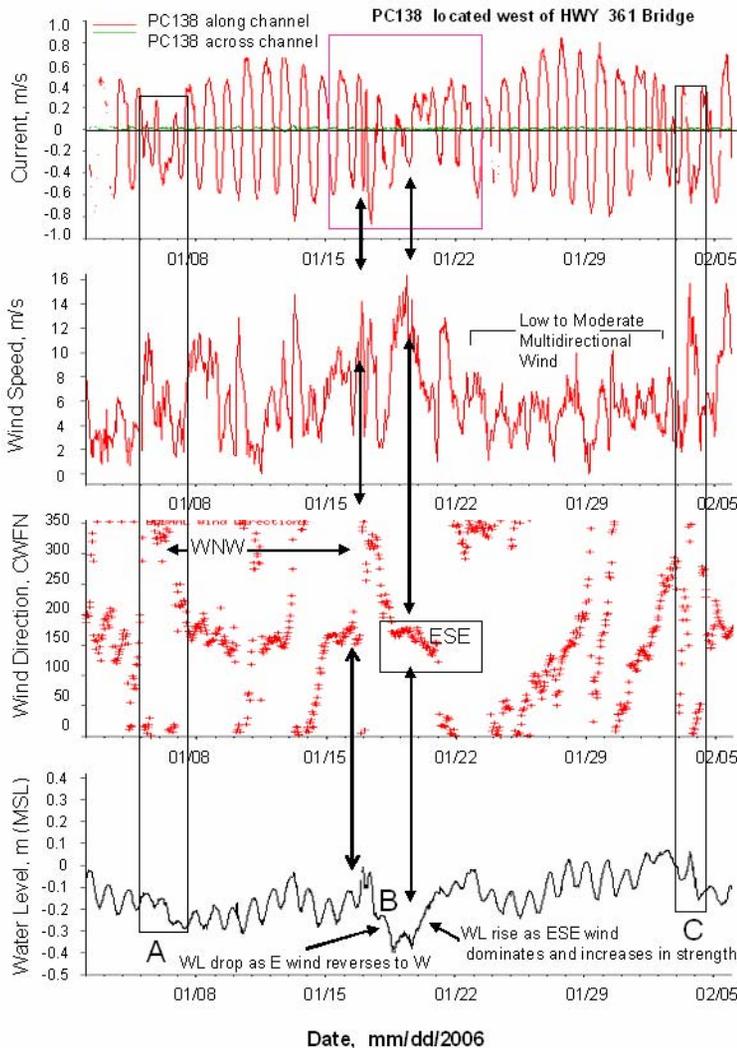
PC138

1. Tidal signal is strong.
2. Ebb flow is enhanced by strong W and NW wind during frontal passage.
3. Flood flow is enhanced by strong ESE winds which dominate in the region, so current is flood biased.
4. Values in range predicted in the 1997 report.

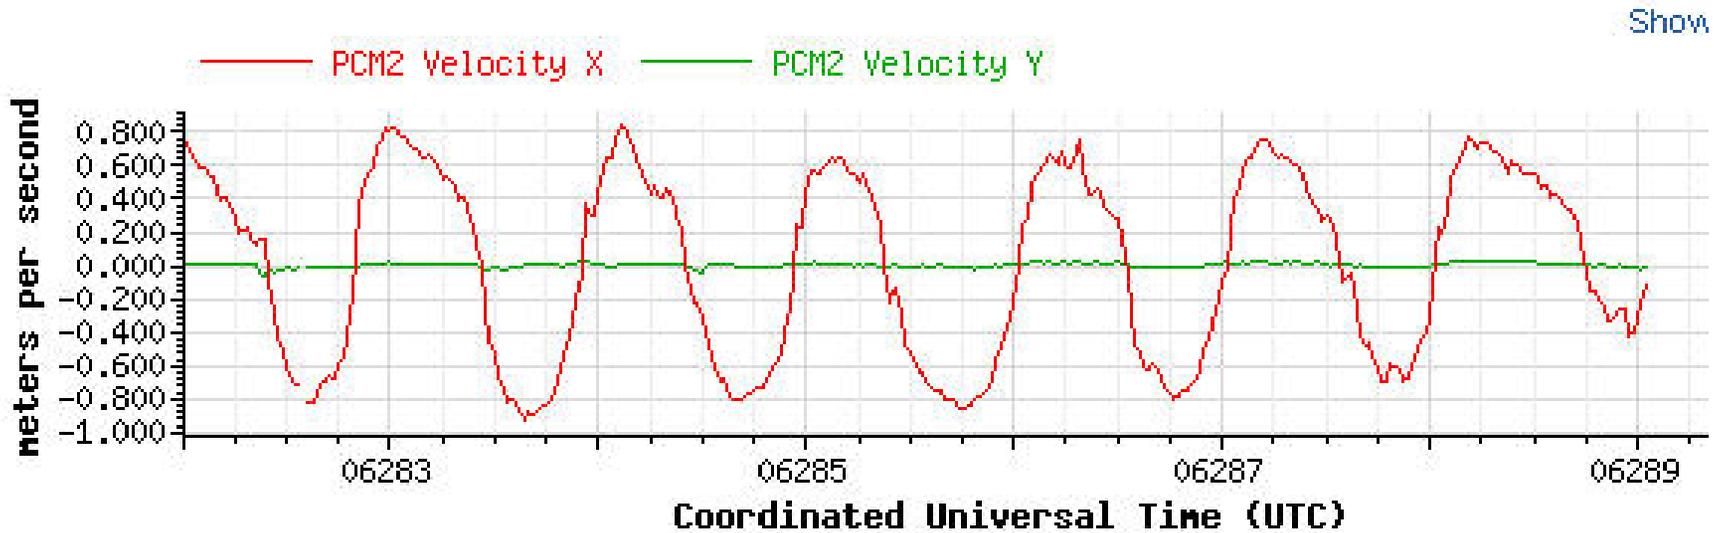
Current

Last week, plotted on web site

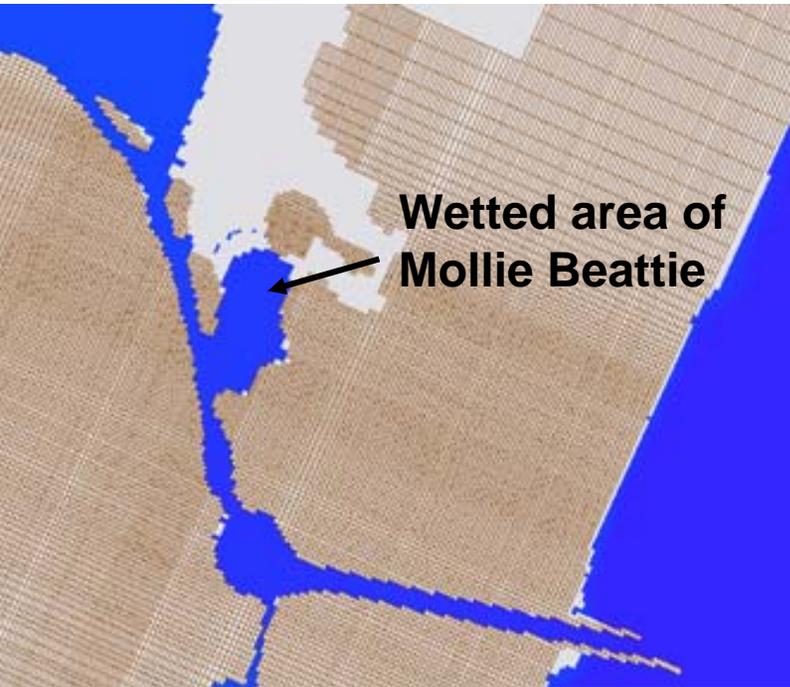
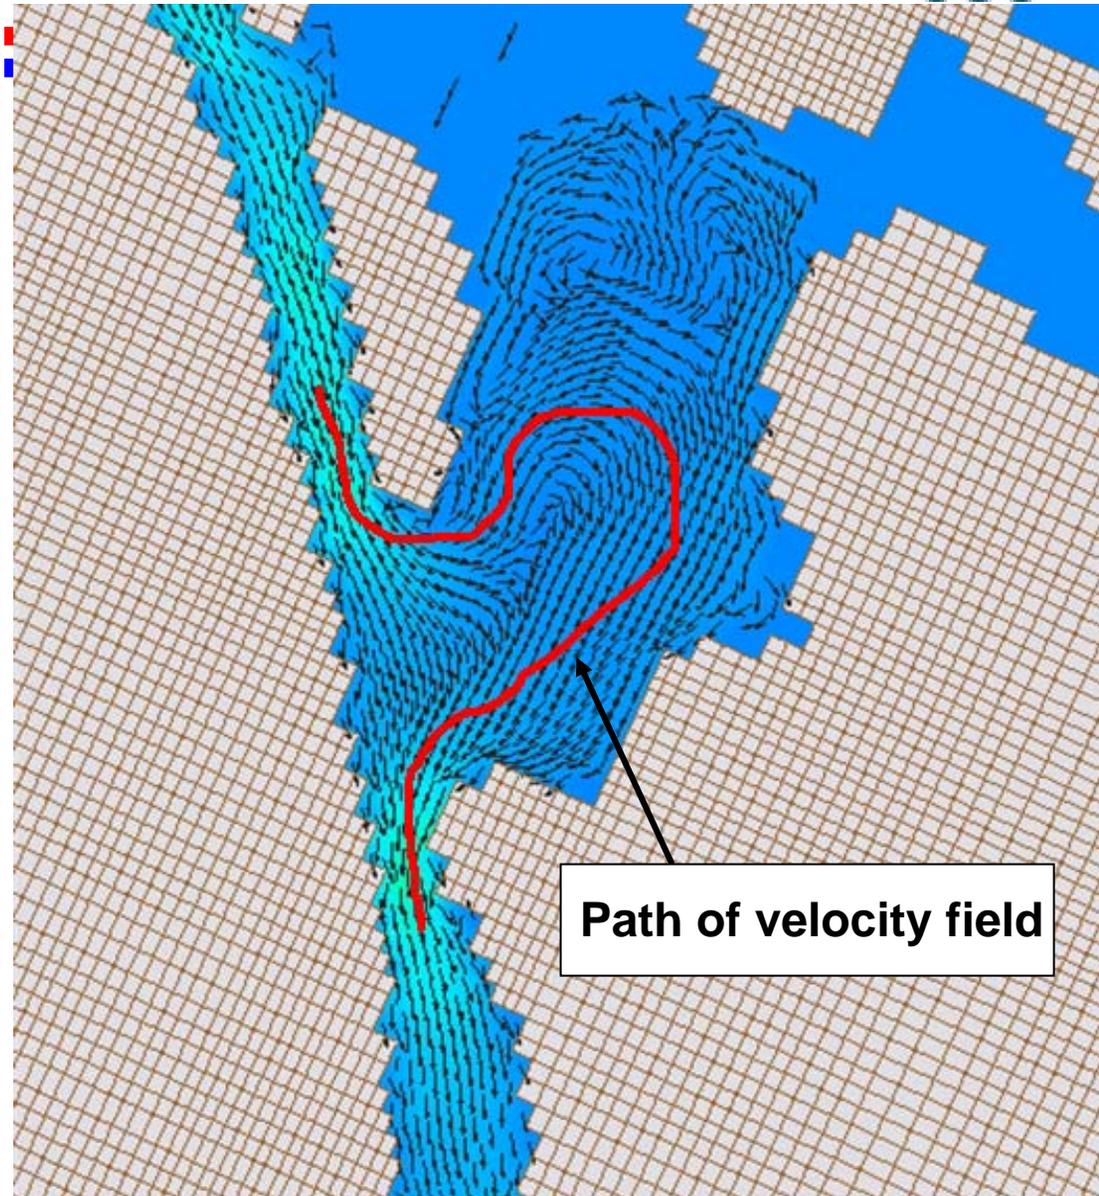
Preliminary Exploration of Circulation on Mollie Beattie Coastal Habitat Community, Mild Wind, With Channel

- Wind from north at 3 m/s
- Mild winter wind
- Flushing of flats during ebb and flood flow

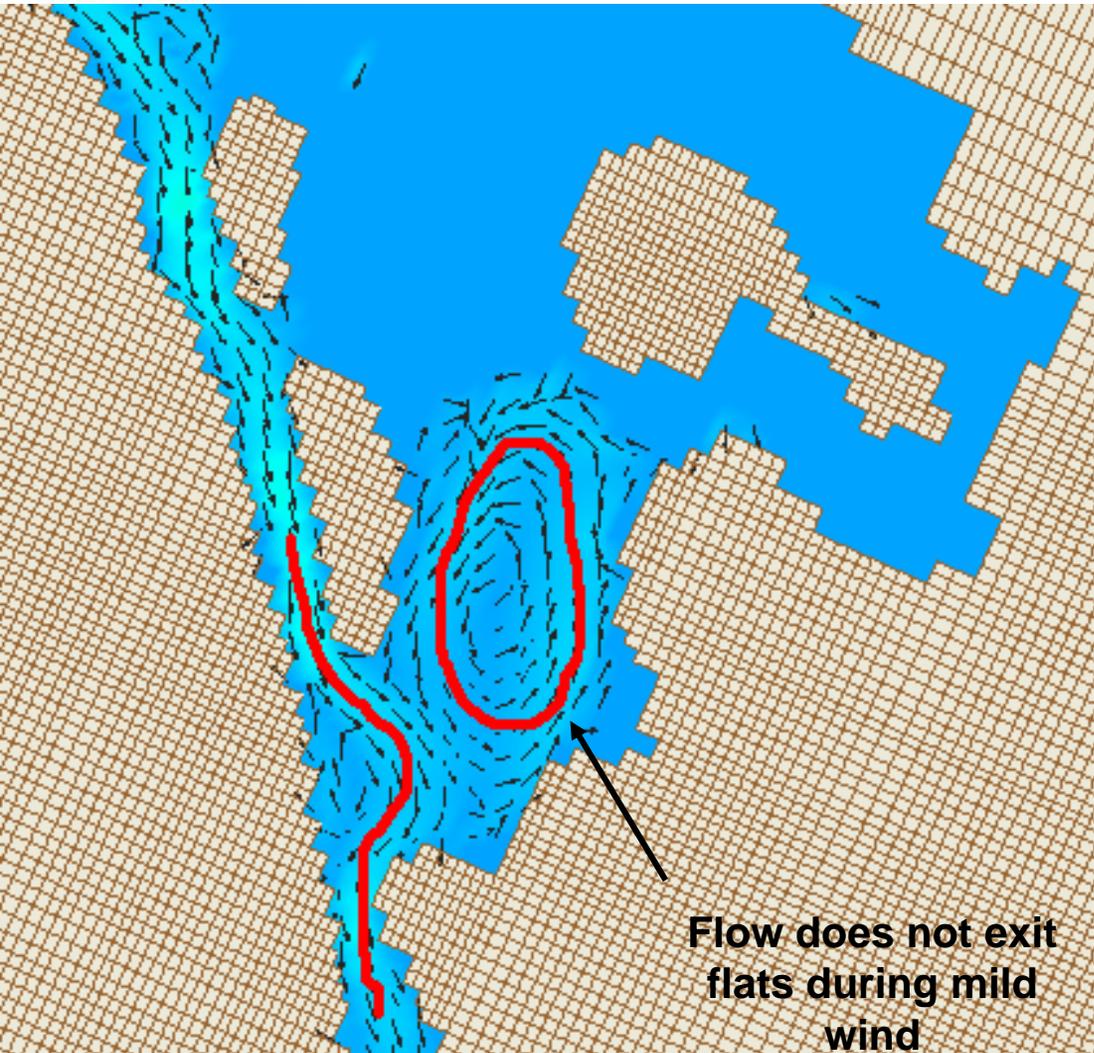
Without Packery Channel, Mild Wind

Flow does not exit flats during mild wind

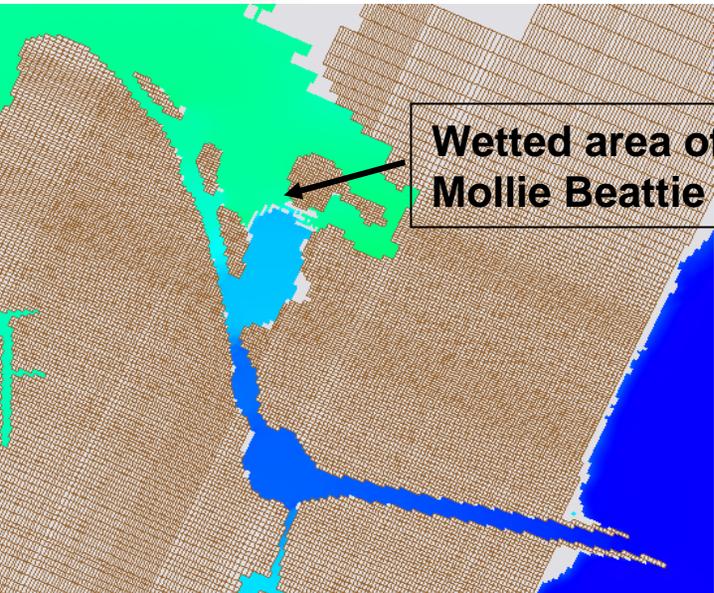
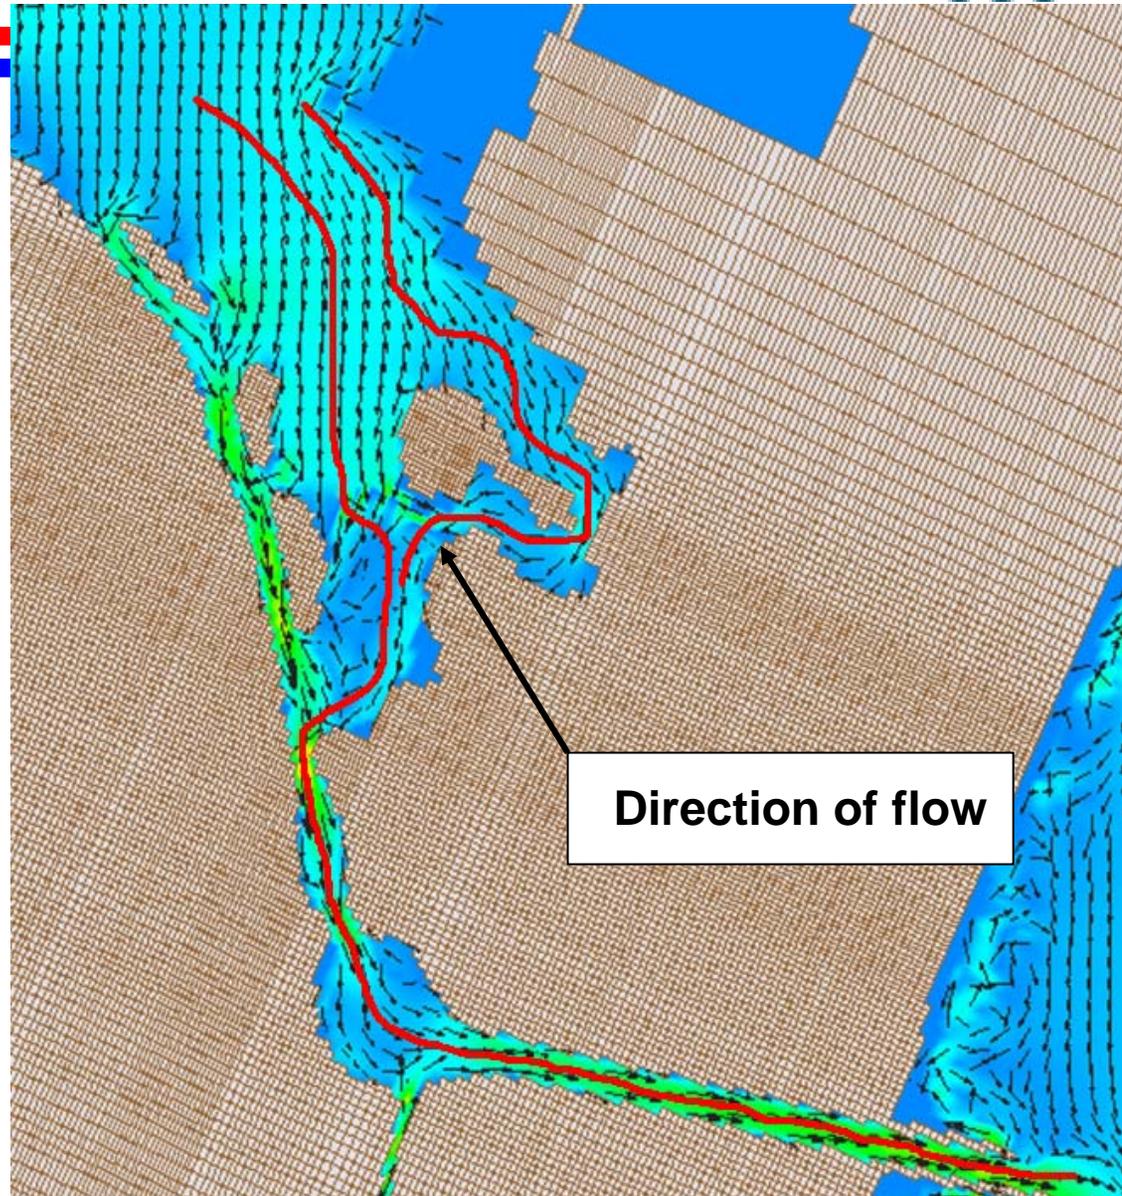
With Packery Channel, Strong Wind

- During strong wind ~ 14 m/s blowing from north
- Winter condition during strong northeasters
- Model shows flushing of flats during ebb and flood flow

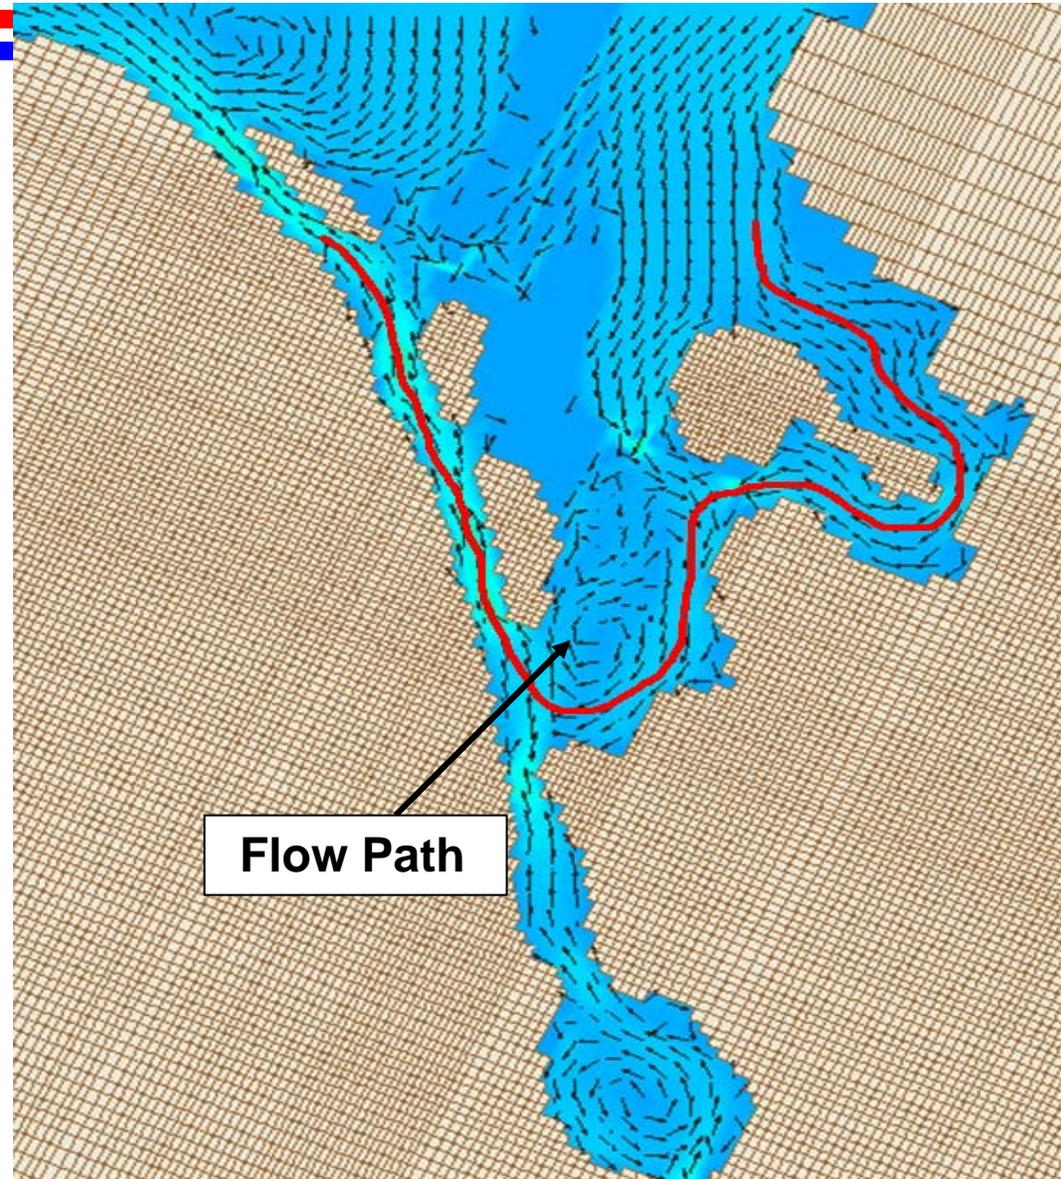
Without Packery Channel, Strong Wind

- During north wind with velocity of ~ 14 m/s
- Without inlet, flushing of flats is seen only during strong wind
